# HOLY LOCH FLEET MOORING UNDERWATER INSPECTION REPORT

JUNE 1984

OCEAN ENGINEERING  
AND CONSTRUCTION PROJECT OFFICE  
CHESAPEAKE DIVISION  
NAVAL FACILITIES ENGINEERING COMMAND  
WASHINGTON, DC 20374

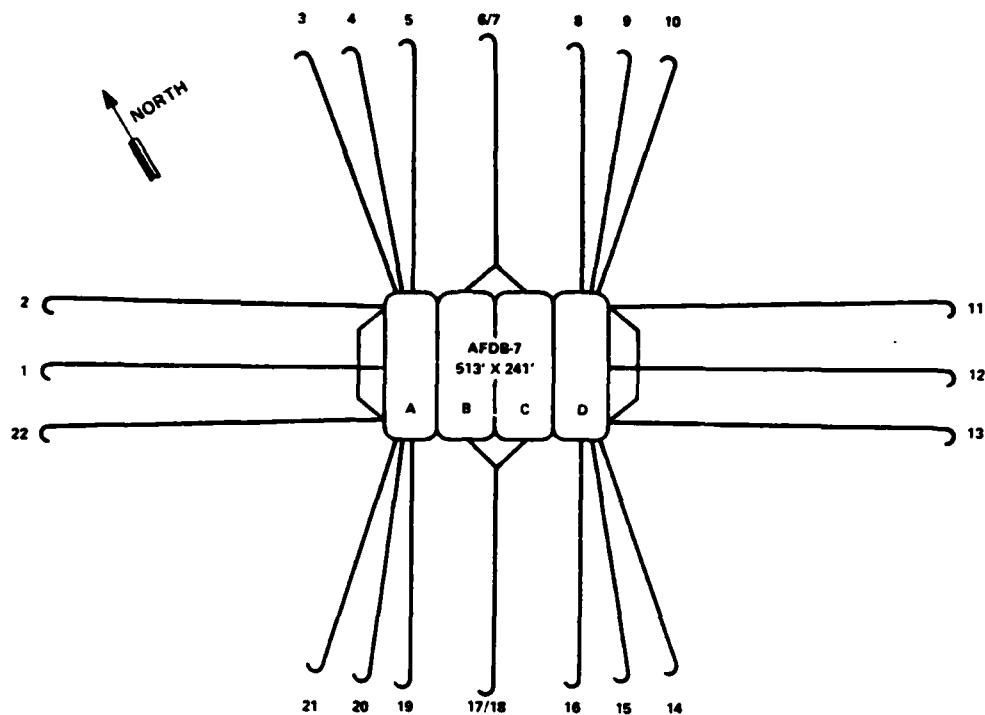
Figure 3. Schematic of AFDB-7 Mooring, Showing Ground Leg Numbers

3.3 AFDB-7 Mooring. Catenaries for all anchor chain subassemblies were measured to be 2 to 8 degrees greater than the angles determined during installation. This indicates additional slack in the chain probably caused by some anchor drag and straightening of the chain installed on the bottom. Seven legs were shortened by removing six to nine links per leg to restore the catenaries of all legs to about 70 degrees. Each of the 20 anchor chain subassemblies inspected had a measurement greater than 90 percent of its original 3-inch wire diameter.

Catenary Profile. Several observations were made in order to determine the catenary of each leg. Table A-1 contains the catenary data obtained while Figure 4 lists the parameters considered. Catenary angles for all anchor chain subassemblies were measured to be 2 to 8 degrees greater than the angles determined in July 1983. This indicates additional slack in the chain probably caused by some anchor drag and straightening of chain installed on the bottom. Seven legs were shortened (see Table A-1) by removing six to nine links per leg to restore catenary angles to about 70 degrees.

This mooring is in satisfactory condition for continued fleet use. It is recommended that catenary angles be rechecked in 1985 following the high winds normally encountered during winter storms.

Conclusions/Recommendations. The AFDB-7 mooring is in satisfactory condition for continued fleet use. Catenary angles should be rechecked in the spring of 1985 after the high winds normally encountered during winter storms.

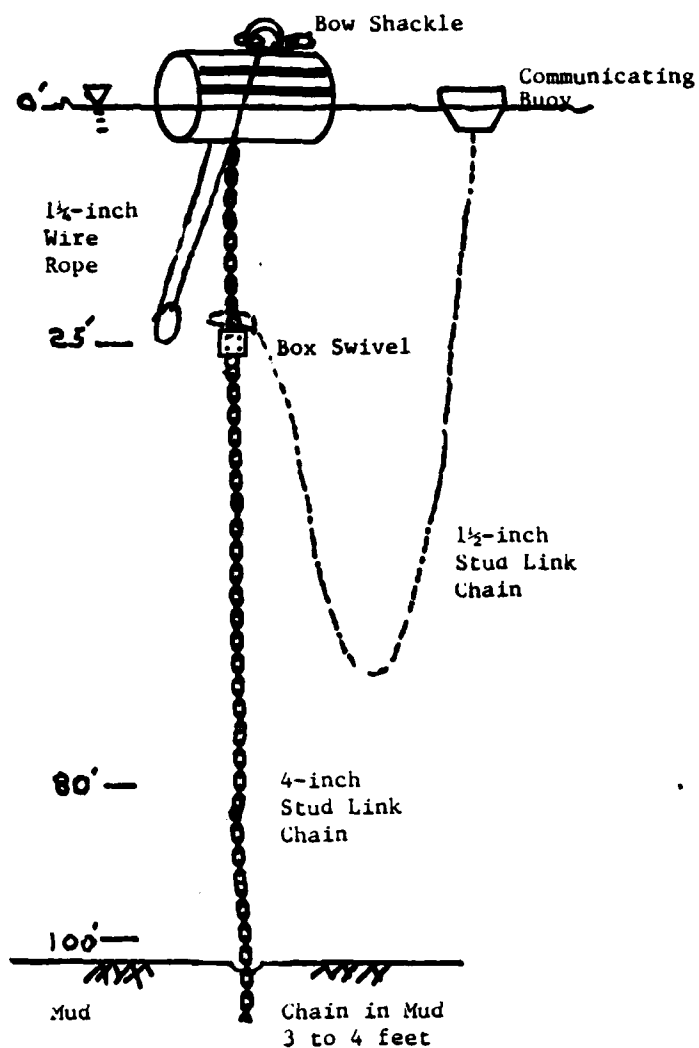
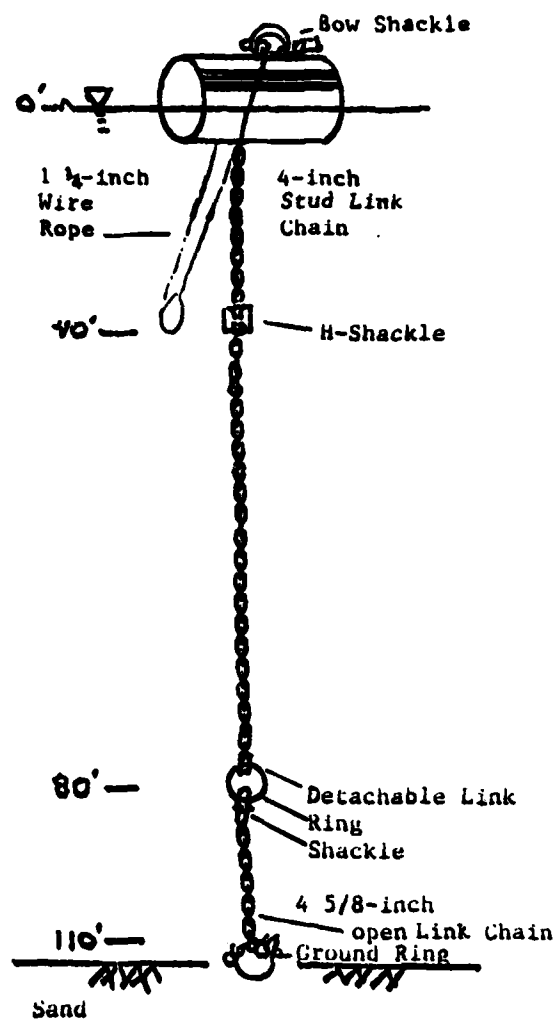
Figure A-1. Mooring A-2 Buoy Systems

- o All chain measurements were greater than 90 percent of their original wire diameter.
- o The bow buoy ring shackle (see Annex C) has a 1/4-inch-deep groove worn into its inner surface.
- o It was noted that British and U.S. Navy chain and hardware are being used together. See Annex C.
- o The bow buoy has a slight list which may be due to a loss of water tight integrity. The cause of this list should be investigated at the earliest possible time.

Buoy. This is a 6-foot 7-inch-diameter ("X" class) cylindrical buoy with a length of 14 3/4 feet. It has wooden fenders, and the upper hull is covered with rust. Below the water line the hull is covered with 4 1/2 inches of marine growth. The buoy has a slight list to starboard which may indicate loss of watertight integrity. A buoy shackle with a wire diameter of 6 1/2 inches is attached to the top link of the riser chain. The bow of this shackle has a 1/4-inch-deep groove worn in it by wire rope.

Comments and Recommendations. This buoy system (see Figure A-1) is in satisfactory condition for continued operational use. The buoy should be inspected to determine the cause of the list.
